National Dam Inspection Program.
Hutchinson Reservoir Dam Number 2
(NDI-PA-215), Ohio River Basin, Redstone
Creek, Fayette County, Pennsylvania.
Phase I Inspection Report.

PHASE I INSPECTION REPORT
NATIONAL DAM INSPECTION PROGRAM

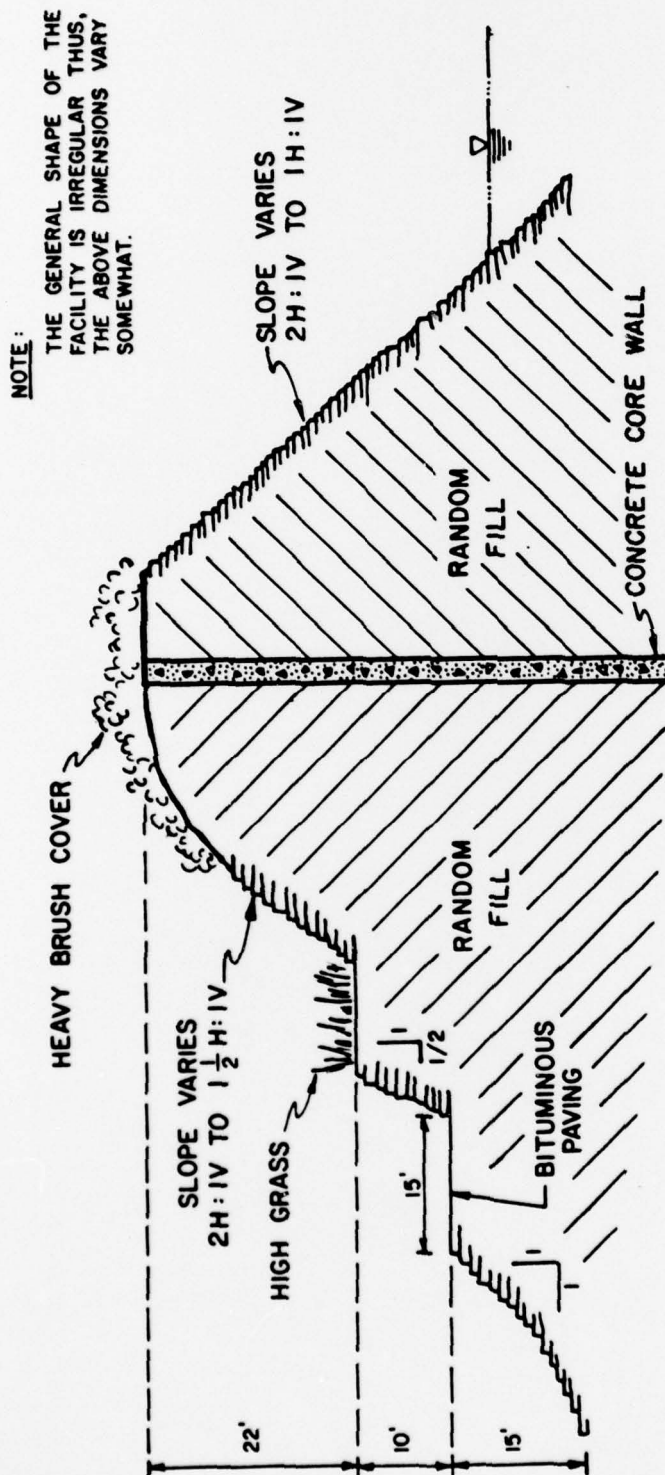
FIGURE 2 - TYPICAL CROSS SECTION

SLOPES ARE CONSTRUCTED OF HAND PLACED RIPRAP AS INDICATED.
